REPORT

Manby H1L15 Breaker Incident - July 5, 2010

Document ID	IES_REP_0670
Document Name	Manby H1L15 Breaker Incident - July 5, 2010
Issue	Issue 1.0
Reason for Issue	Final release.
Effective Date	October 20, 2010

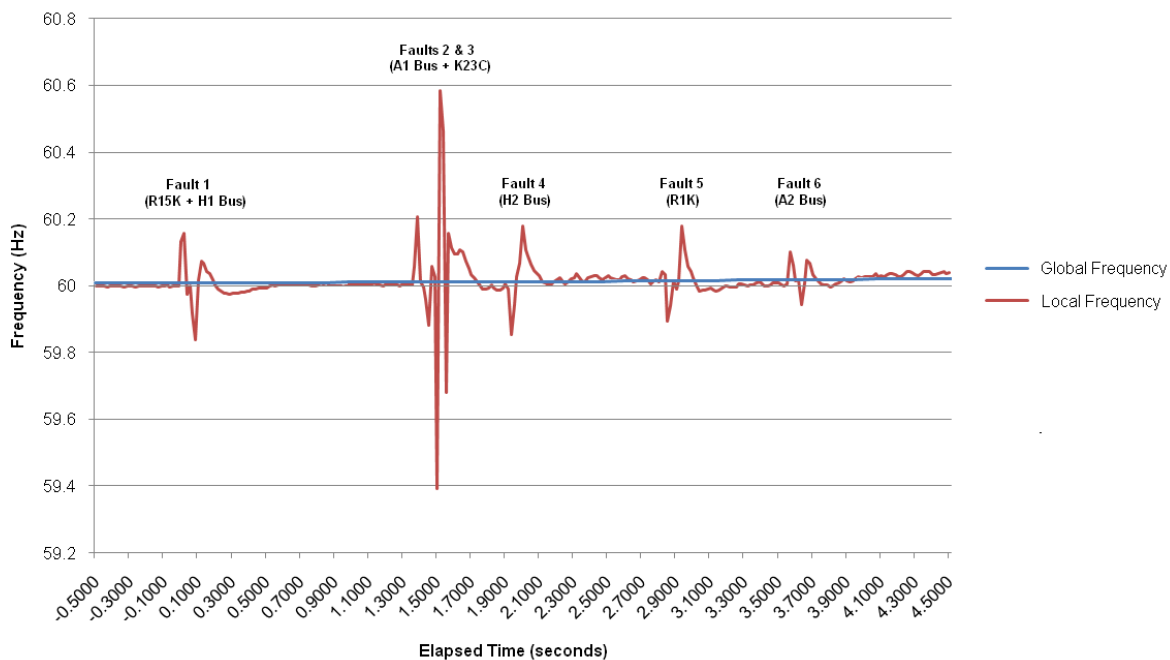
Figure 4 Frequency Trends – July 5th, 2010

The interconnected system remained stable following subsequent faults at Manby. As seen in the figure below, each fault was cleared within 90 milliseconds while oscillations were damped within 250 milliseconds. The most severe fault occurred approximately 1.5 seconds after the Manby H1L15 failed explosively. This was the result of a 3-phase fault on 230 kV circuit K23C (Manby East – Cooksville).

The frequency trend illustrated below is measured locally at the Claireville 500 to 230 kV transformer station and is a function of how disturbance recorder equipment calculates frequency. The fault and switching actions distort the local voltage waveform, and will appear as frequency spikes at local recorders. It is displayed below for the purpose of easily indentifying the timing and relative severity of each fault. The actual or global interconnection frequency remained very stable throughout the event, experiencing a deviation of less than 0.04 Hz once the load loss was realized.

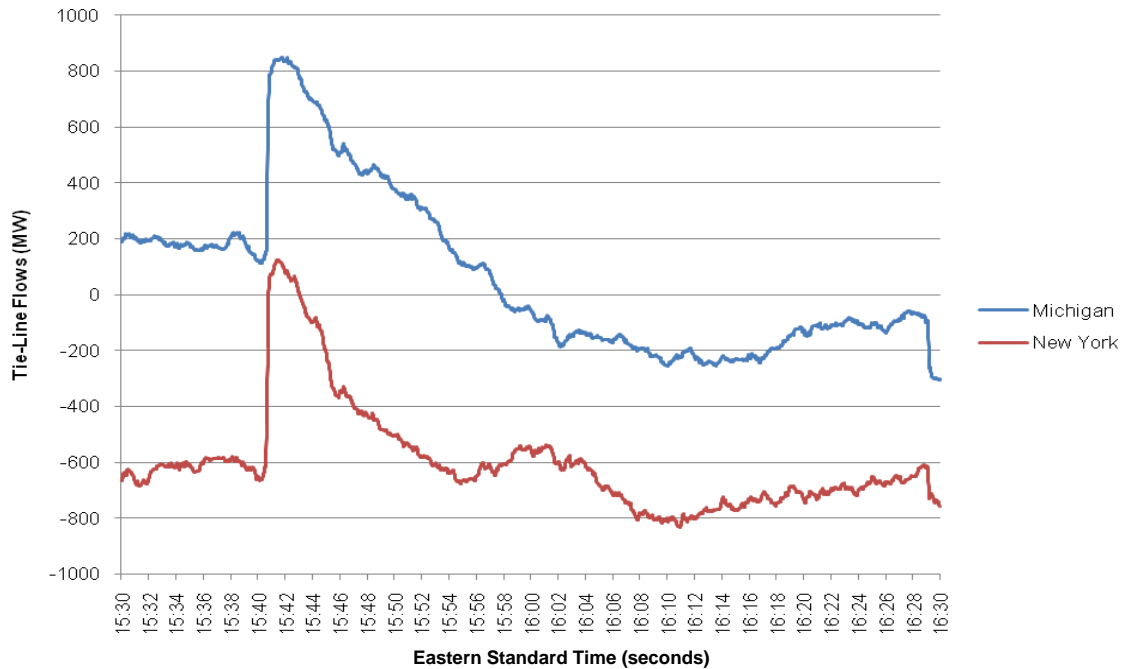
Figure 5 Ontario to Michigan and New York Tie-Line Flows – July 5th, 2010

The Michigan and New York tie-lines saw an increase of 725 MW and 690 MW out of Ontario respectively. Flows were restored to pre-contingency levels within 12 minutes following IESO operator efforts made to reduce ACE to 0 MW. No adverse impact was reported by the IESO’s neighboring reliability coordinators.

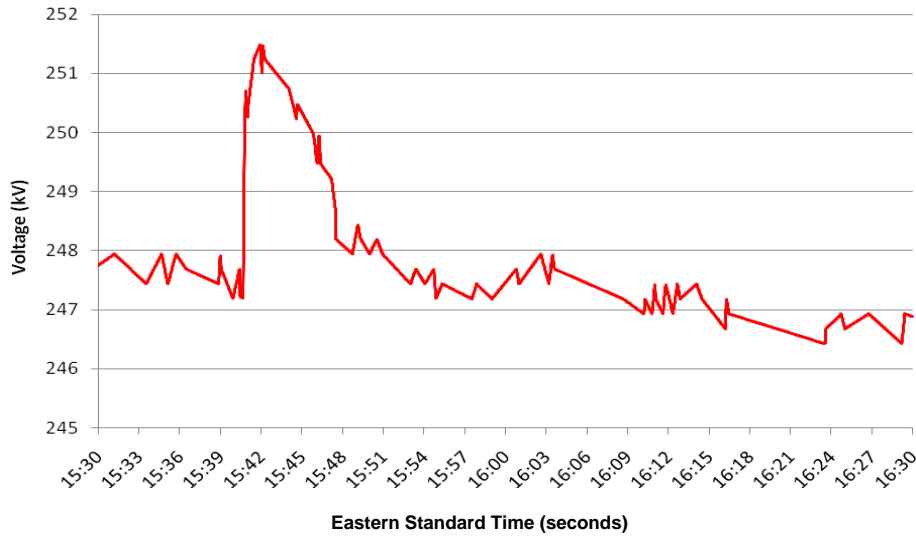
Figure 6 Richview Switching Station 230 kV Voltage – July 5th, 2010

Approximately 1550 MW of load was interrupted as a result of the multiple fault occurrences at the Manby West and East yards. Ontario demand dropped from 24,509 MW to 22,915 MW causing voltages to rise at multiple 230 and 500 kV stations in Southern Ontario as the need for reactive support was diminished by the loss of load. Voltages were quickly reduced to pre-contingency levels through the re-dispatch of both static and dynamic reactive resources. The voltage profile at the Richview 230 kV switching station, located approximately seven kilometers from Manby, shows this response in the following figure.

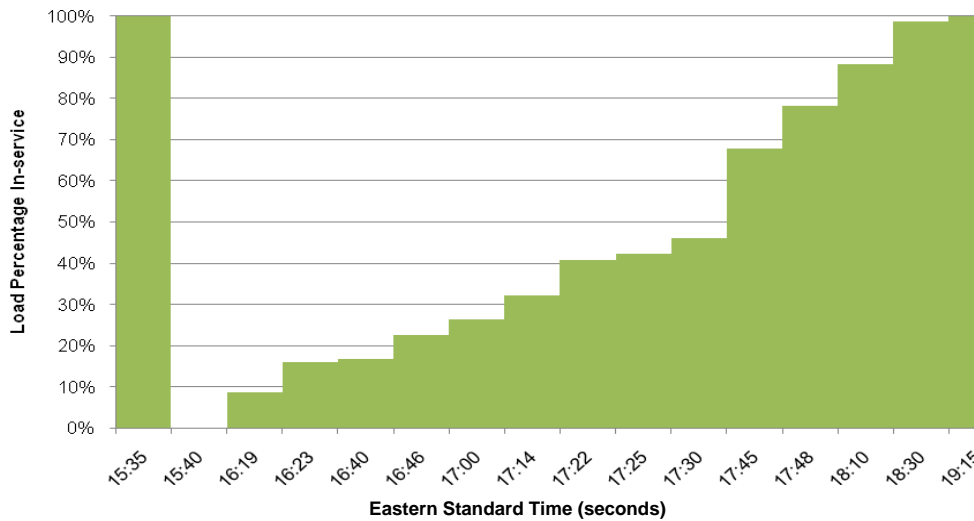
Figure 7 Percentage of Manual Load Restoration – July 5th, 2010

Figure 7 below illustrates how the remaining 902 MW of load removed by configuration was manually restored following the breaker explosion. Total load restoration was completed in just over three and a half hours.

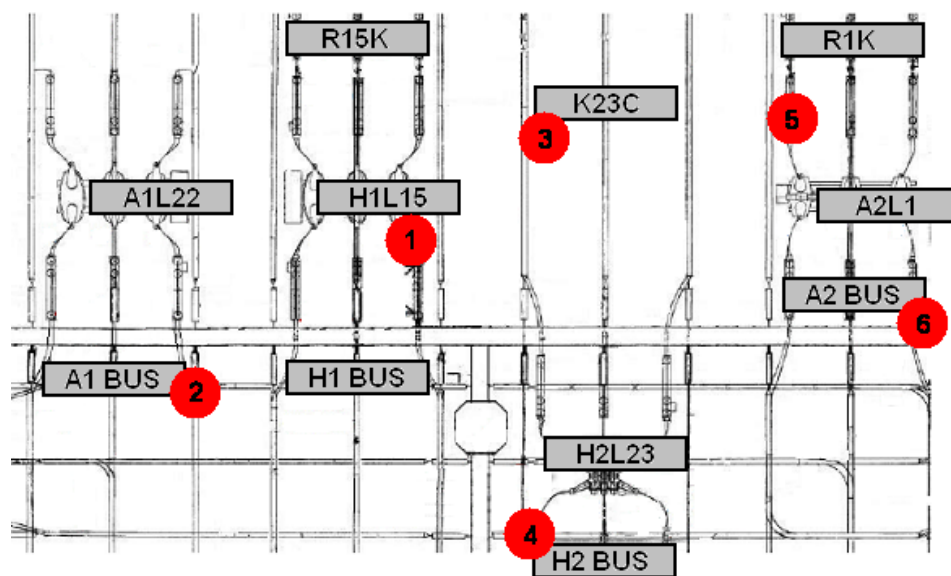
Figure 8 Manby East and West Station Layout with Fault Order & Location

The fault originated internally on the Manby West 230 kV H1L15 breaker. Each subsequent fault that occurred on several Manby busses and emanating 230 kV circuits are believed to be the result of the oil and parts that were shot from the breaker once it exploded. It is believed that the oil became contaminated from the debris and smoke that resulted coincident with the explosion. As indicated in the figure below, the timing and location of each subsequent fault was likely based on the proximity of the faulted equipment to the H1L15 breaker.

Power system disturbance recorded data supports the fact that six independent faults occurred in the Manby West and East yards. Hydro One analysis showed primary line and bus-differential protections operated correctly as each fault was cleared by their respective zone within design criteria timelines. Hydro One's review of this data shows no evidence of any relay equipment saturation which could have led to protection misoperation.

Hydro One has deemed the cause of the failure on the H1L15 breaker the result of oil breakdown due to a high particulate count. The breaker has been in-service for the past 32 years and was not a candidate for replacement. It was determined to be in healthy condition based on previous maintenance and sampling schedules.

By July 9, 2010, all station equipment that was contaminated by soot and smoke from the explosion was cleaned to eliminate the risk of flashover conditions on station equipment.

The Manby West L15L22 breaker, which shares the R15K circuit terminal at Manby with the failed H1L15 breaker, had its above ground cable tray damaged by debris from the explosion. A close inspection of the tray revealed no damage to the cables. The Manby West A1L22 breaker, which sits adjacent to the L15L22 was also declared unavailable as it shares a common DC supply with the other two damaged breakers. Repairs were made to the L15L22 cable tray and the DC supply issue was resolved on the A1L22 breaker within several days. Both of these breakers were made available for service on July 10, 2010. These actions allowed the R15K circuit terminal at Manby to be restored to service with the exception of the failed H1L15 breaker.

The H1L15 breaker was replaced with an SF6-gas breaker on August 20, 2010. This replacement completed the restoration of all equipment at the Manby East and West stations since the incident occurred.

Hydro One identified 39 other breakers across the province that are of the same make and model as the Manby West H1L15. Of the 39 identified, 12 are currently in-service at the Manby station. Since the incident, all of these breakers had two separate oil samples taken and analyzed by two separate labs. This analysis found that no other breakers were at risk such that they would need to be forced out of service for maintenance or replacement.

As part of its ongoing investigation, Hydro One has given consideration to move the normal oil analysis maintenance from a 3 year cycle to an annual cycle.
